Updated Phase I Survey:
Contaminant Survey Checklist
for Proposed Property Transfer
(Rev. 9/2002)

Site Name: Requa AF Radar Site (Atch 1) **County:** Del Norte **State:** CA

Yurok Reservation Updated Phase 1 Survey Narrative
Requa Air Force Station Radar Site
NPS deed listing tract number 03-165

**RE: Draft - Asbestos Debris Investigation
Former Air Force Radar Station Location (Investigation Area IA-7)
Requa Formerly Used Defense Site (FUDS)
Requa, California
Yurok Reservation
ATC PROJECT NO.: 38.28580.0003**

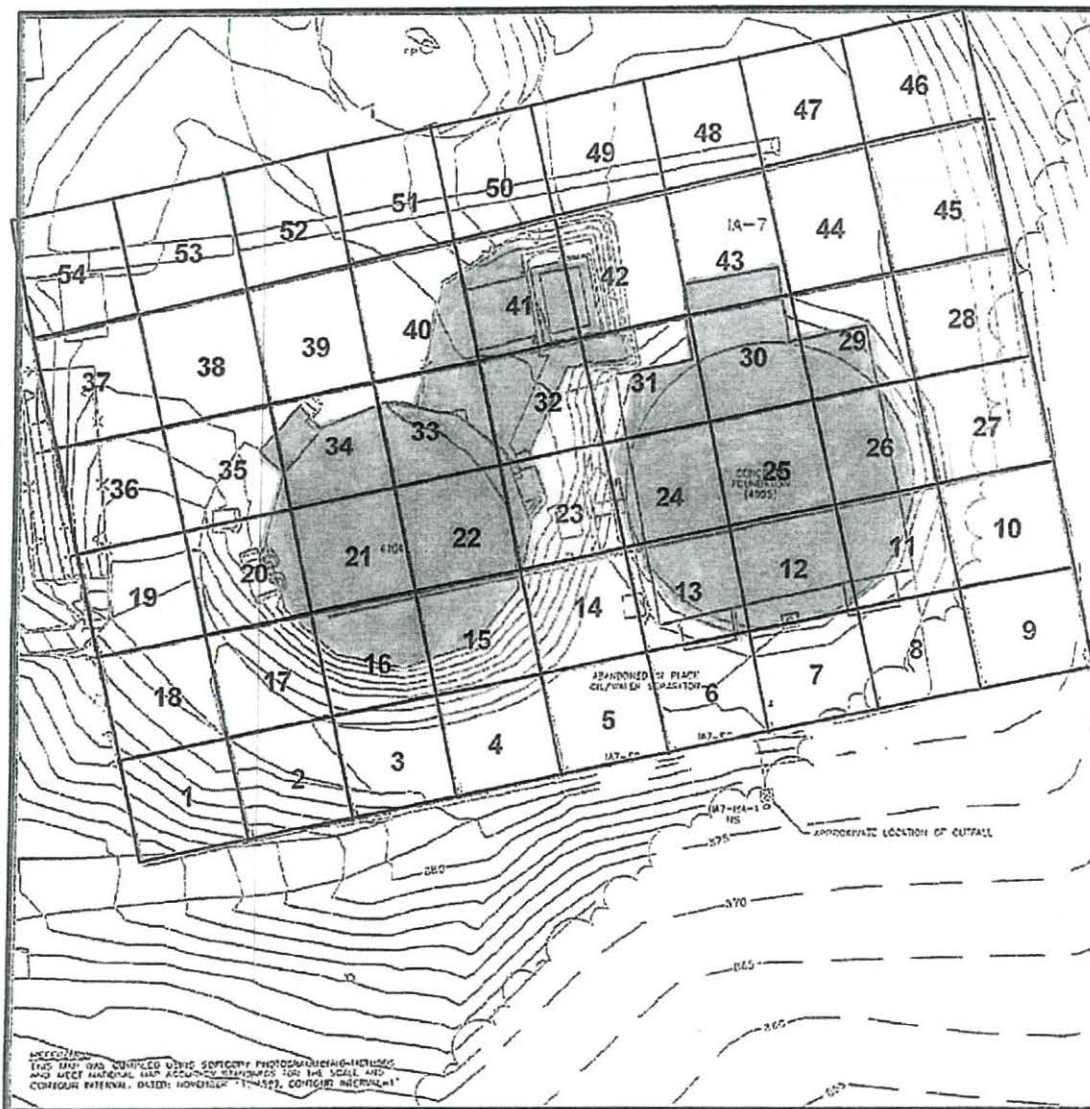
APPENDIX A
SITE PLAN & GRID LOCATIONS

ATC visually inspected the investigation area for evidence of building material debris. Various debris was visible throughout the entire investigation area but the majority of suspect building debris visible on the surface was located on the two concrete pads located in the center of the investigation area. Subsurface debris was noted in the area to the south and west of the western concrete pad and down the slope from the eastern concrete pad (See the Site Plan and Grid Locations diagram in Appendix A).

ATC identified various asbestos containing materials apparently associated with the former USAF radar station located at the site. ATC recommends that all building material debris including buried debris in the identified areas (See Site Plan & Grid Locations in Appendix A), be treated as an ACM and be removed from the site by a qualified contractor per all federal, state and local regulations.

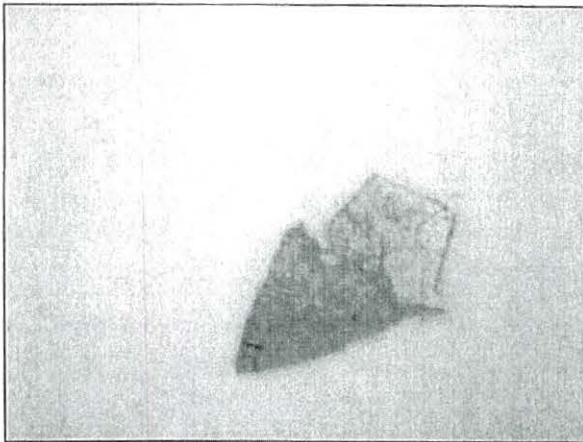
Photo 1: Photo of asbestos containing Textured Paint-White and Tan, Samples 7A, 7B, & 7C.

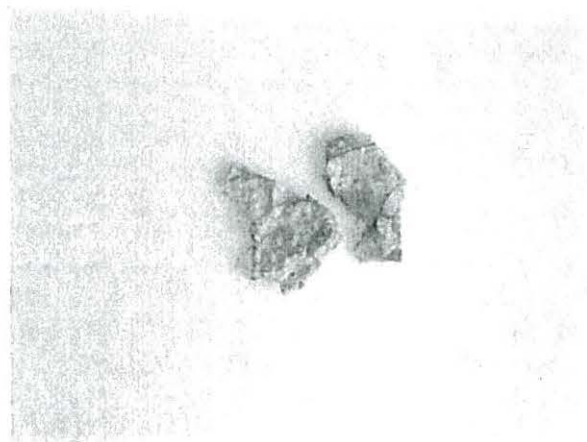
Photo 2: Photo of asbestos containing Rubbery Material-White and Green, Samples 8A, 8B, & 8C.

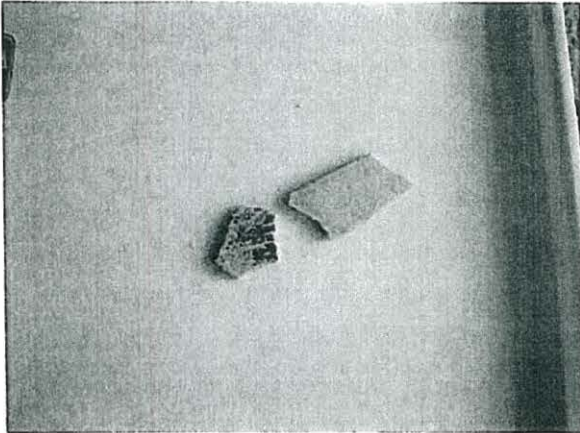
Photo 3: Photo of asbestos containing Floor Tile – Beige and Black Mastic, Samples 11A, 11B, 11C and 20A.

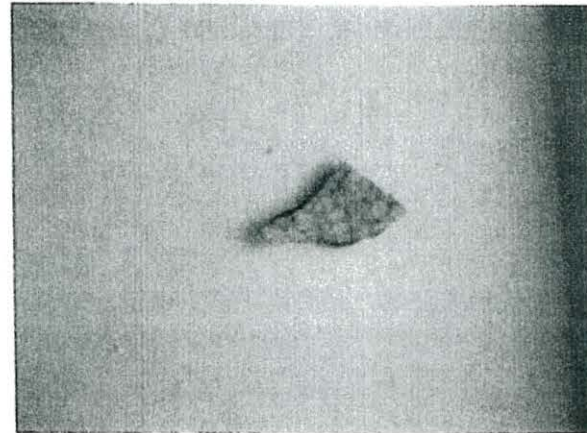
Photo 4: Photo of asbestos containing Pebble Sheet Floor - Beige, Samples 12A & 12B.

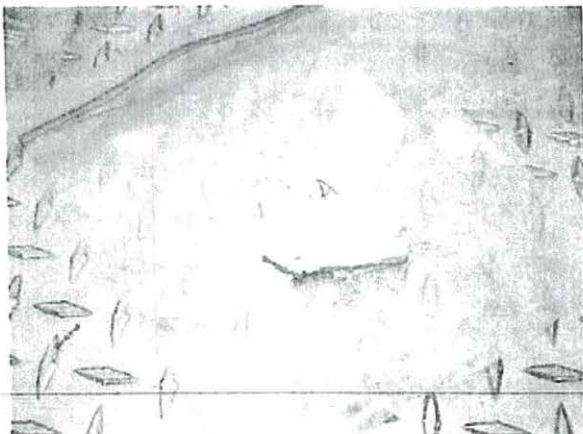
Photo 5: Photo of asbestos containing Floor Tile – Beige, Sample 20A.

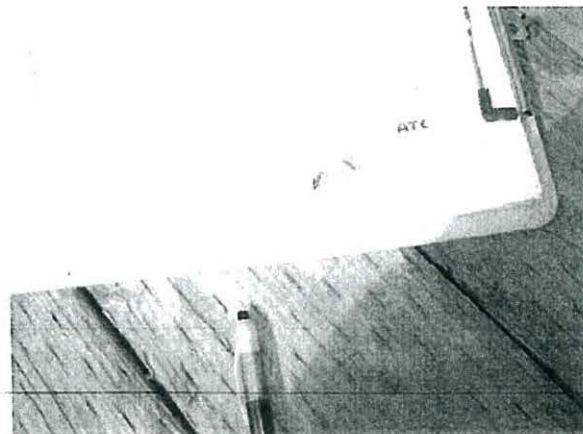
Photo 6: Photo of asbestos containing White Joint Compound Like Material, Sample 22A

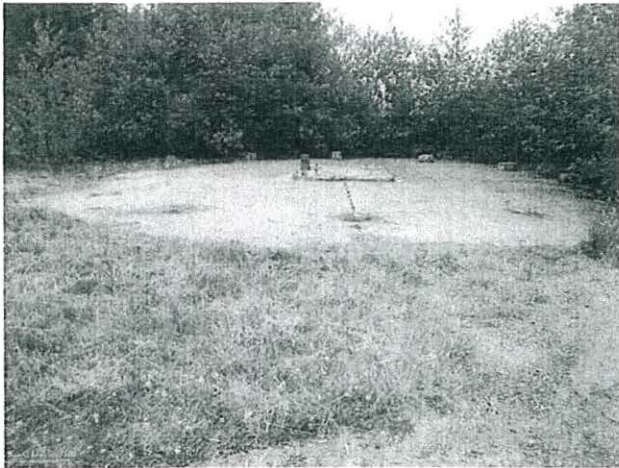
Photo 1: Upper concrete pad following clean up.

Personnel of LVI performed the debris clean up activities on August 4, 2009. LVI removed the asbestos containing construction debris by hand and placed it in a 6-mil plastic bag and labeled it for disposal. The waste was then transported by LVI to the Altamont Landfill located in Livermore, California. A Non-Hazardous Waste Data Form was generated and followed the waste to the Altamont Landfill. A copy of the Data Form and Waste Management acceptance form are presented in Attachment B. Photographs following the debris clean up activities are located in Attachment C.

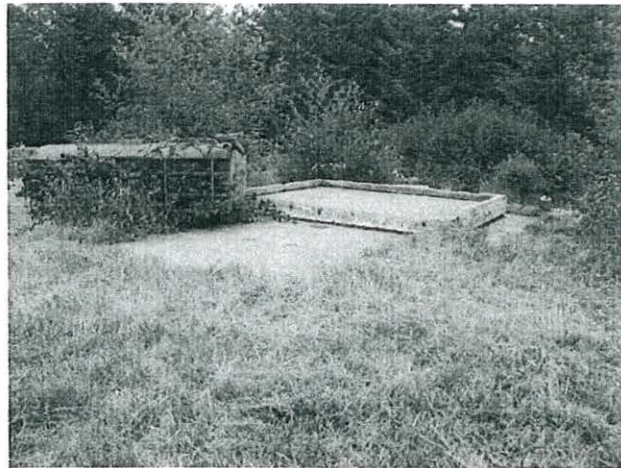
Photo 2: Upper square concrete pad following clean up.

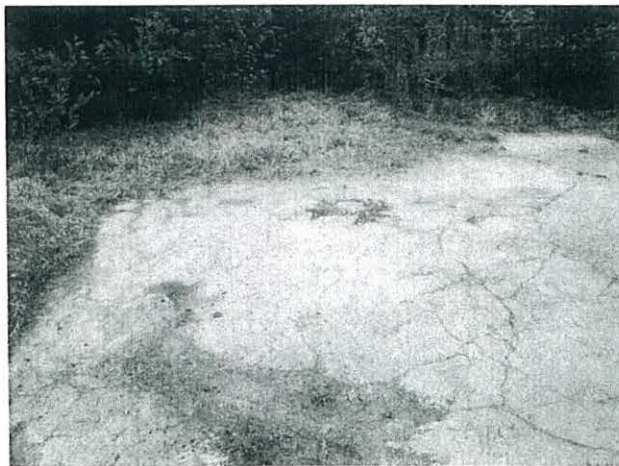
Photo 3: Close up of upper concrete pad following clean up.

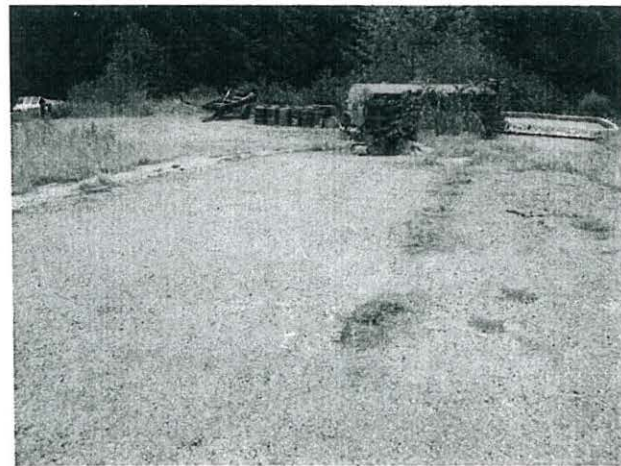
Photo 4: Upper round and square pads following clean up.

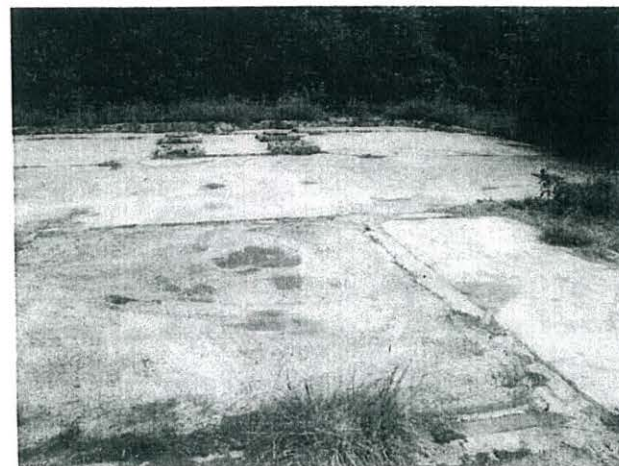
Photo 5: Lower concrete pad following clean up.

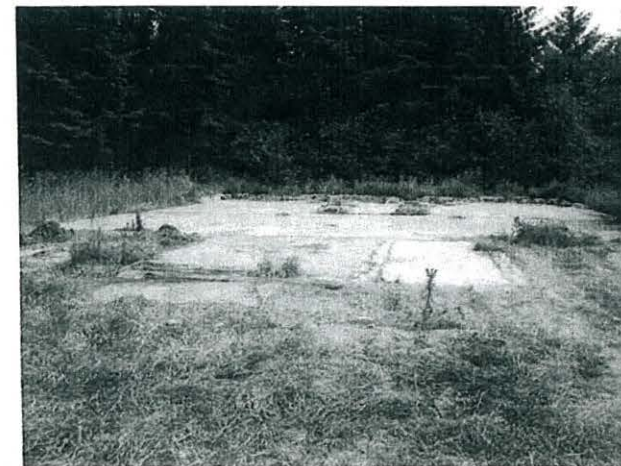
Photo 6: Lower concrete pad following clean up.

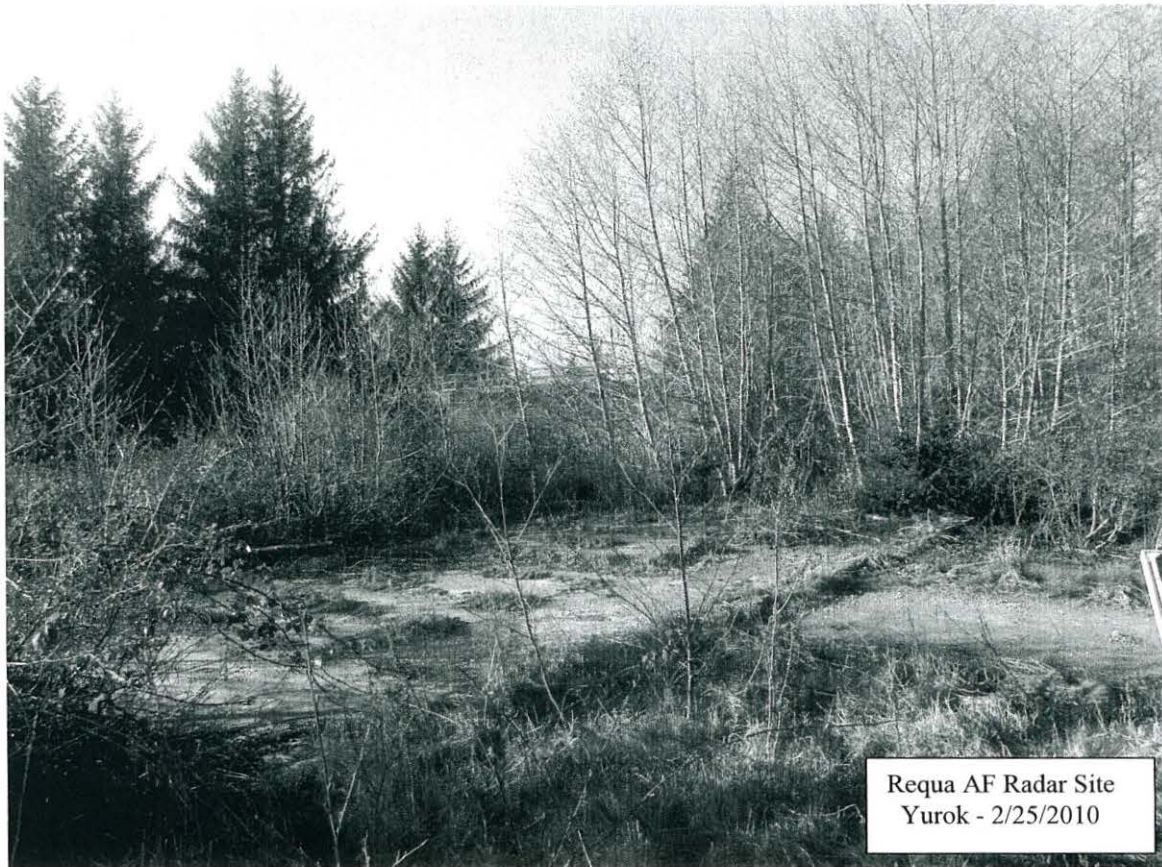
Photo # 1

Standing in the middle on the concrete radar pad and looking north at the foundation of building 102 and further towards the radar site boundary fencing at building 100 on the adjacent property. Building 100 is down gradient to the radar site property.

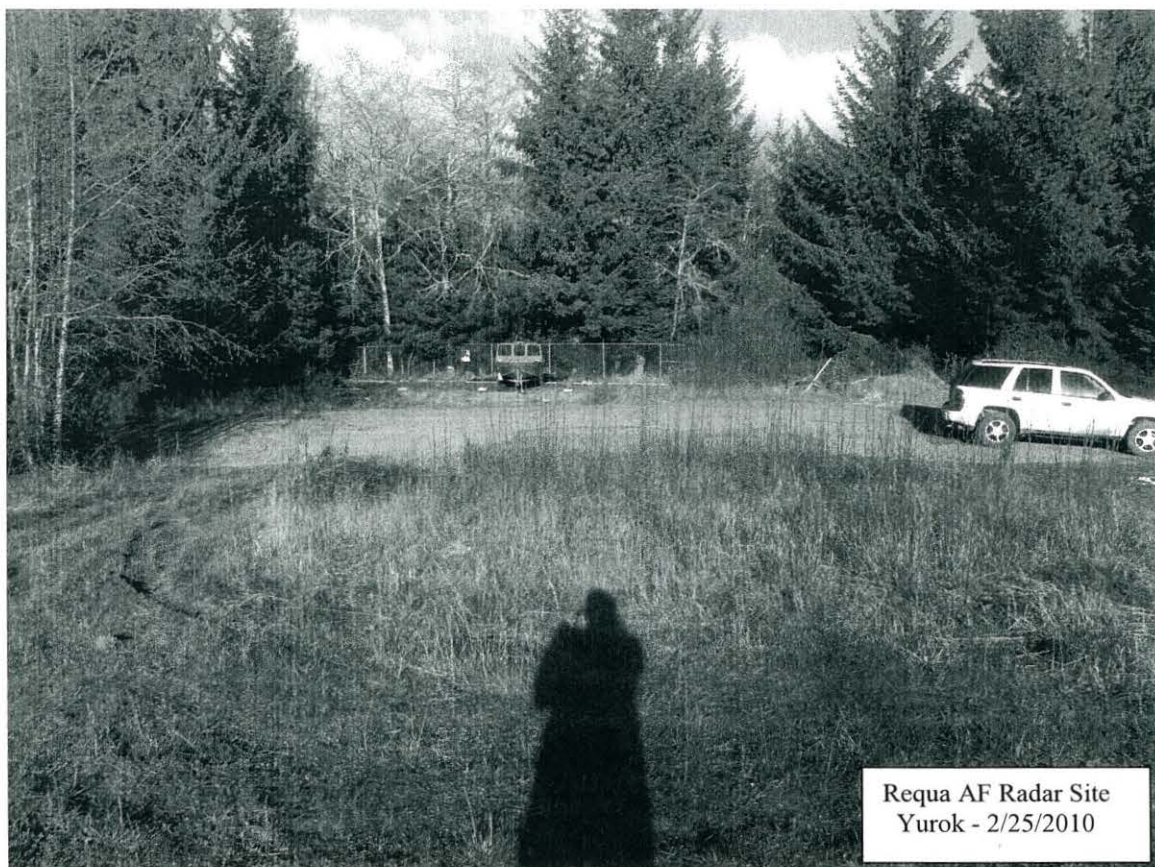
Photo # 2

Standing in the northeast corner of the concrete radar pad and looking west towards the entry road parking turnout and the radar site boundary fencing beyond the removed build 106 concrete pad.

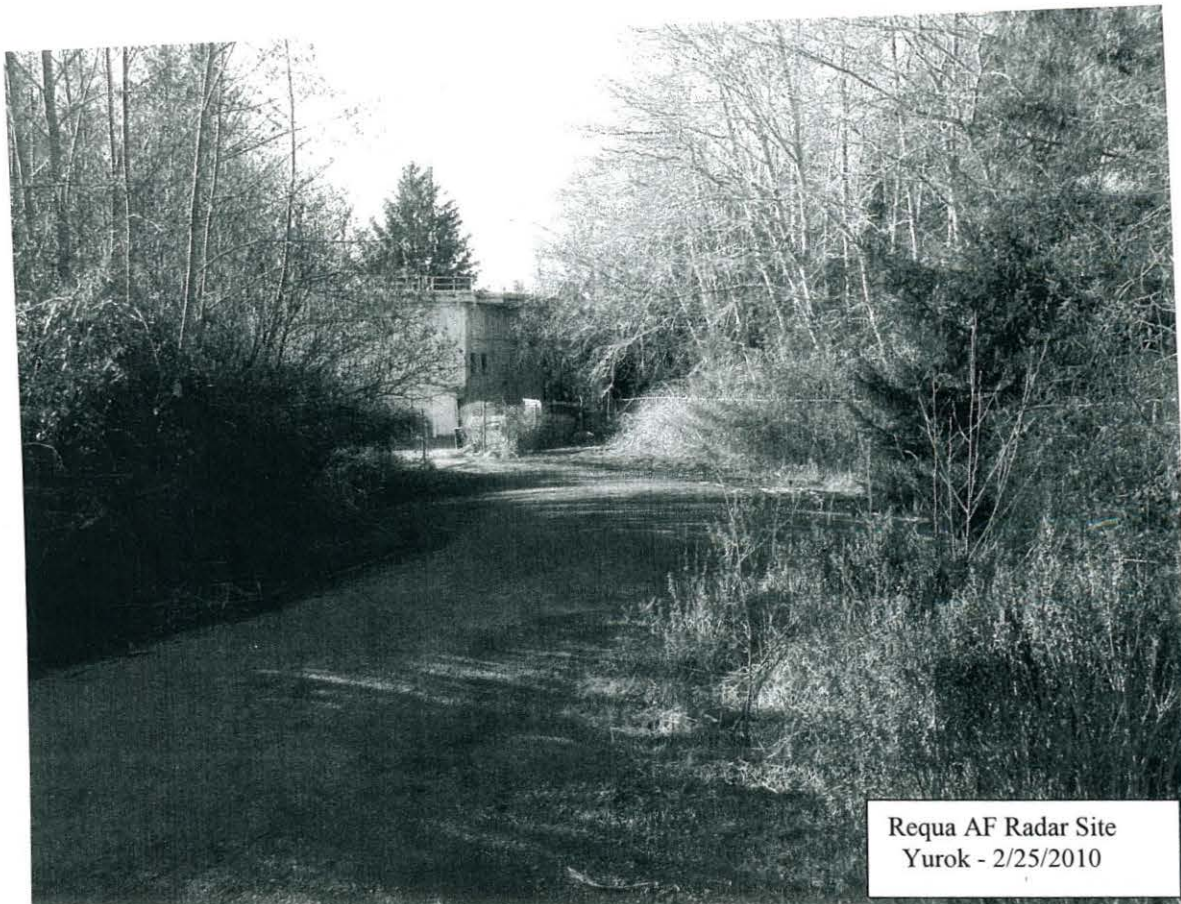
Photo # 3

Looking north from the west entry road of the radar site property. The gated fence barely visible at the end of the road is the entrance to the radar property.

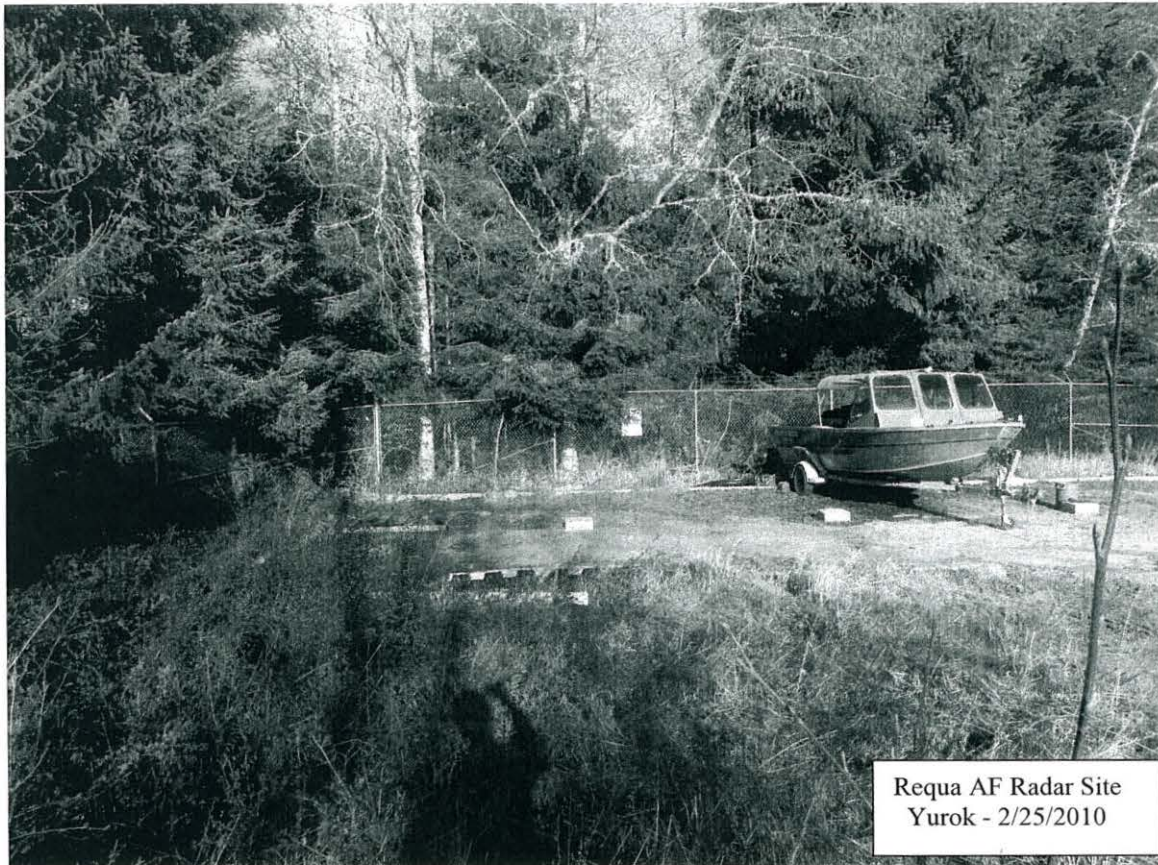
Photo # 4

Standing at the entrance road at the west portion of the radar site and looking east towards the northern end of the removed Building 106 concrete pad and the radar site boundary fencing. The boat on the concrete pad is temporarily stored by the Yurok Tribe.

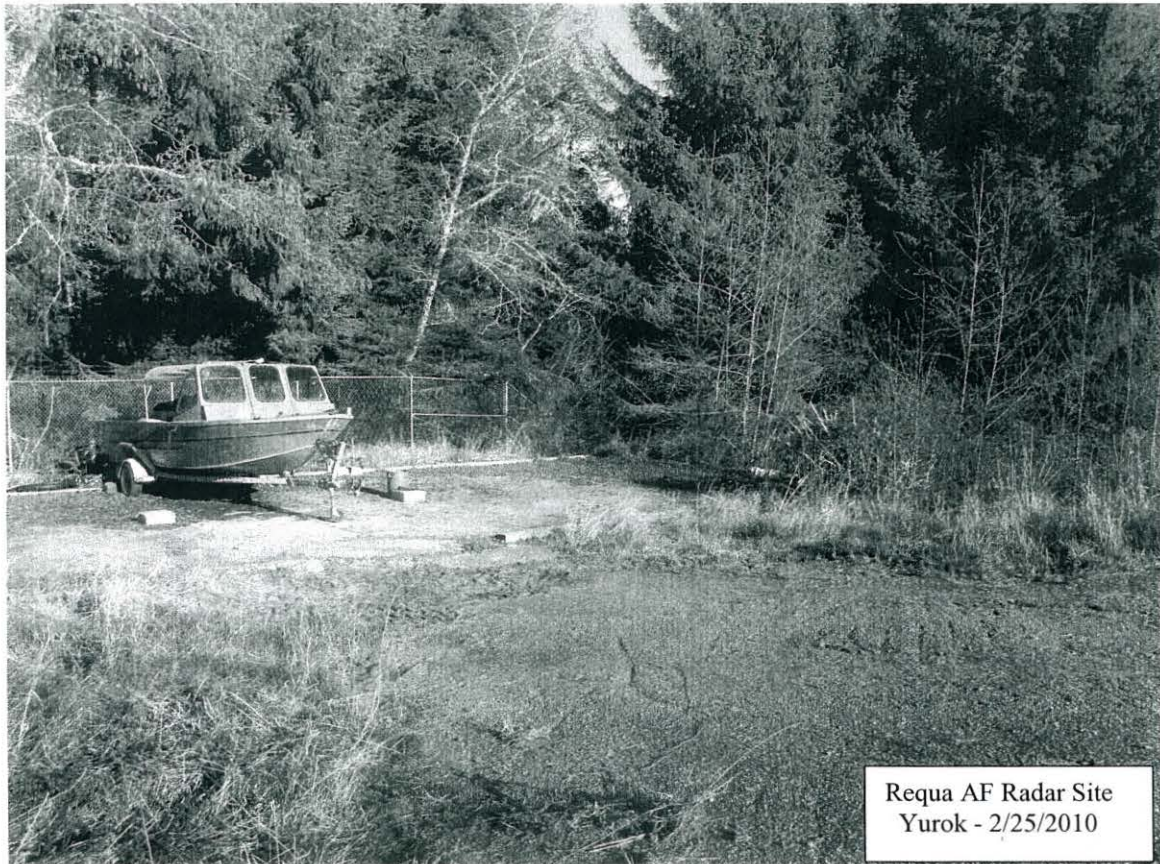
Photo # 5

Standing at the turnout of the entrance road at the west portion of the radar site and looking east towards the northern portion of the removed Building 106 concrete pad and the radar site boundary fencing. The boat on the concrete pad is temporary storage by the Yurok Tribe.

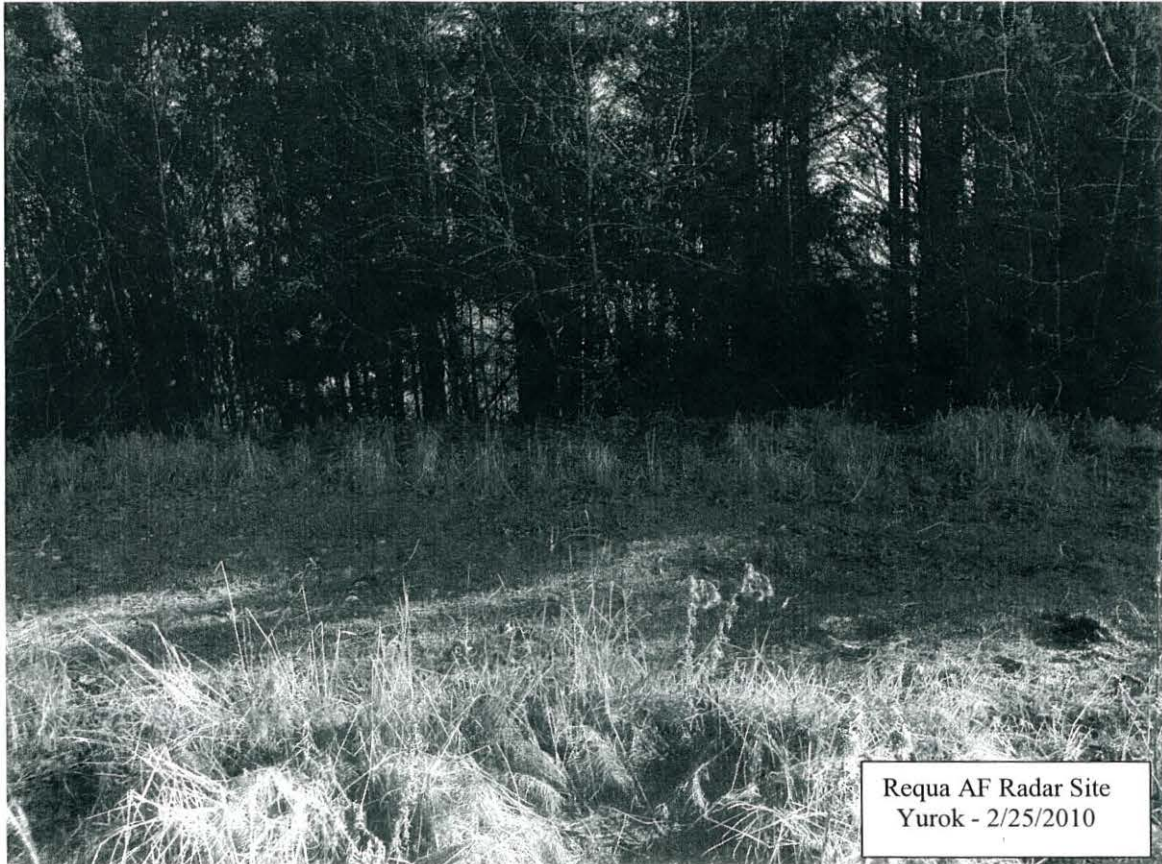
Photo # 6

Standing at the southern portion of the property of the radar site and looking towards the southern property boundary beyond the outfall.

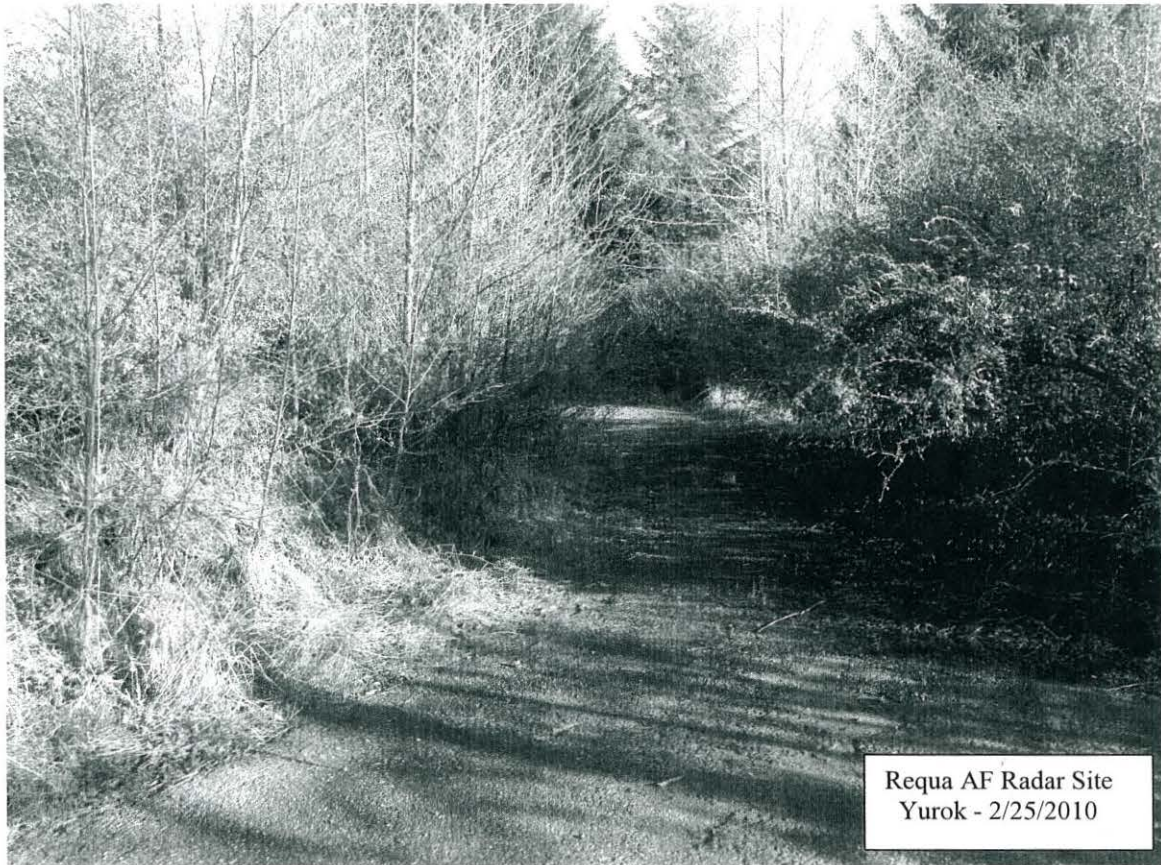
Photo # 7

Standing at the western portion of the property and looking east with the southern portion of the radar pad towards the right and at the top of this roadway.

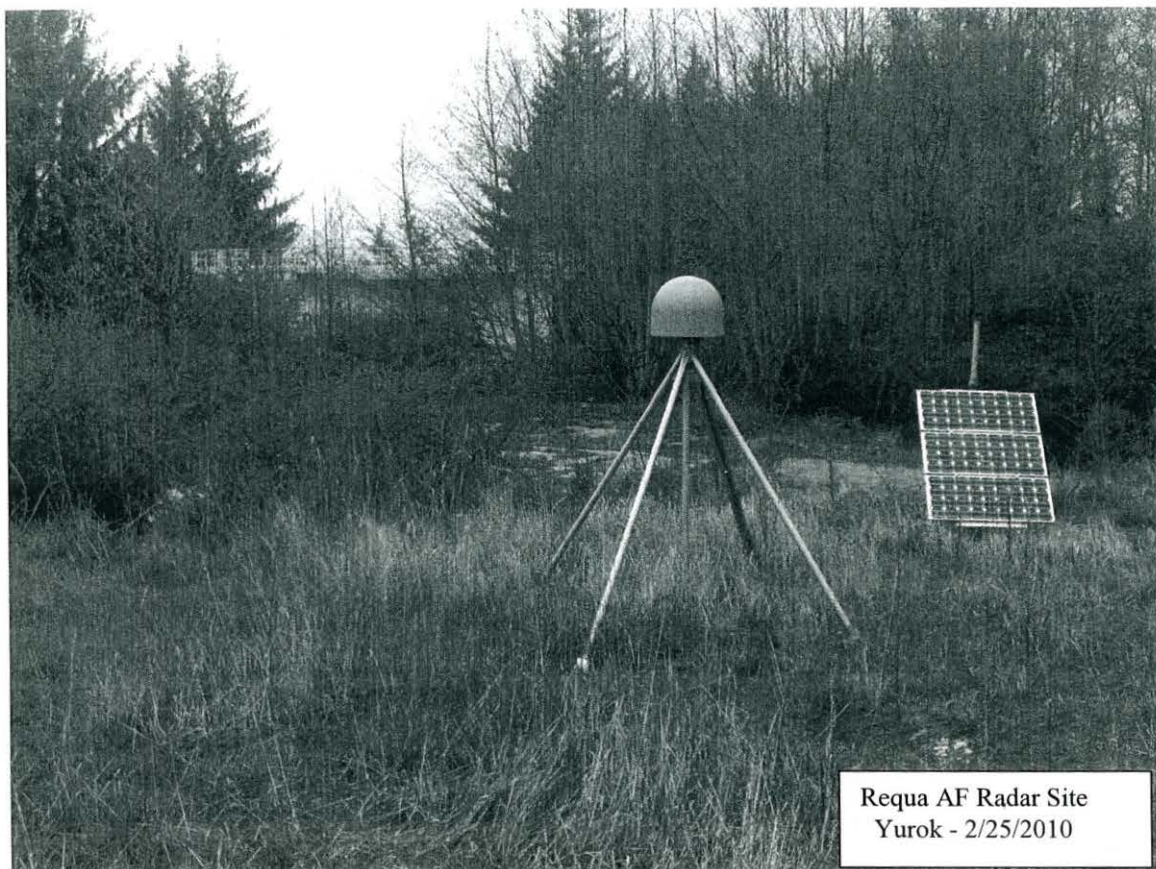
Photo # 8

Standing in the middle on the concrete radar pad and looking West at the adjacent property and the radar site boundary fencing. The building adjacent is down gradient to the radar site property and is the abandoned transportation building. The unit in the middle of the picture is a USGS seismic monitoring system.

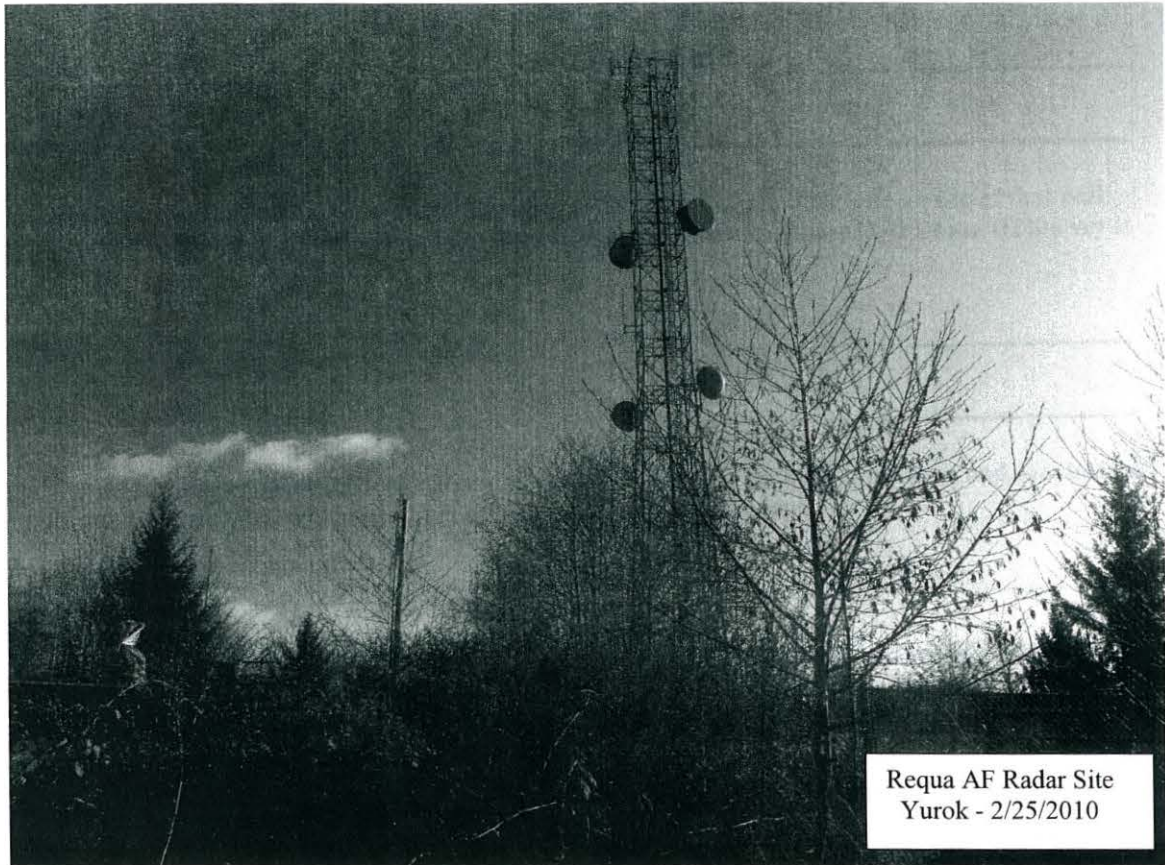
Photo # 9

**Standing on the concrete radar pad and looking Southwest at the adjacent property
at the cell phone tower presently in operation.**
